# Operational Failure Modes

# Noppikoski Dam

# Sayano-Shushenskaya

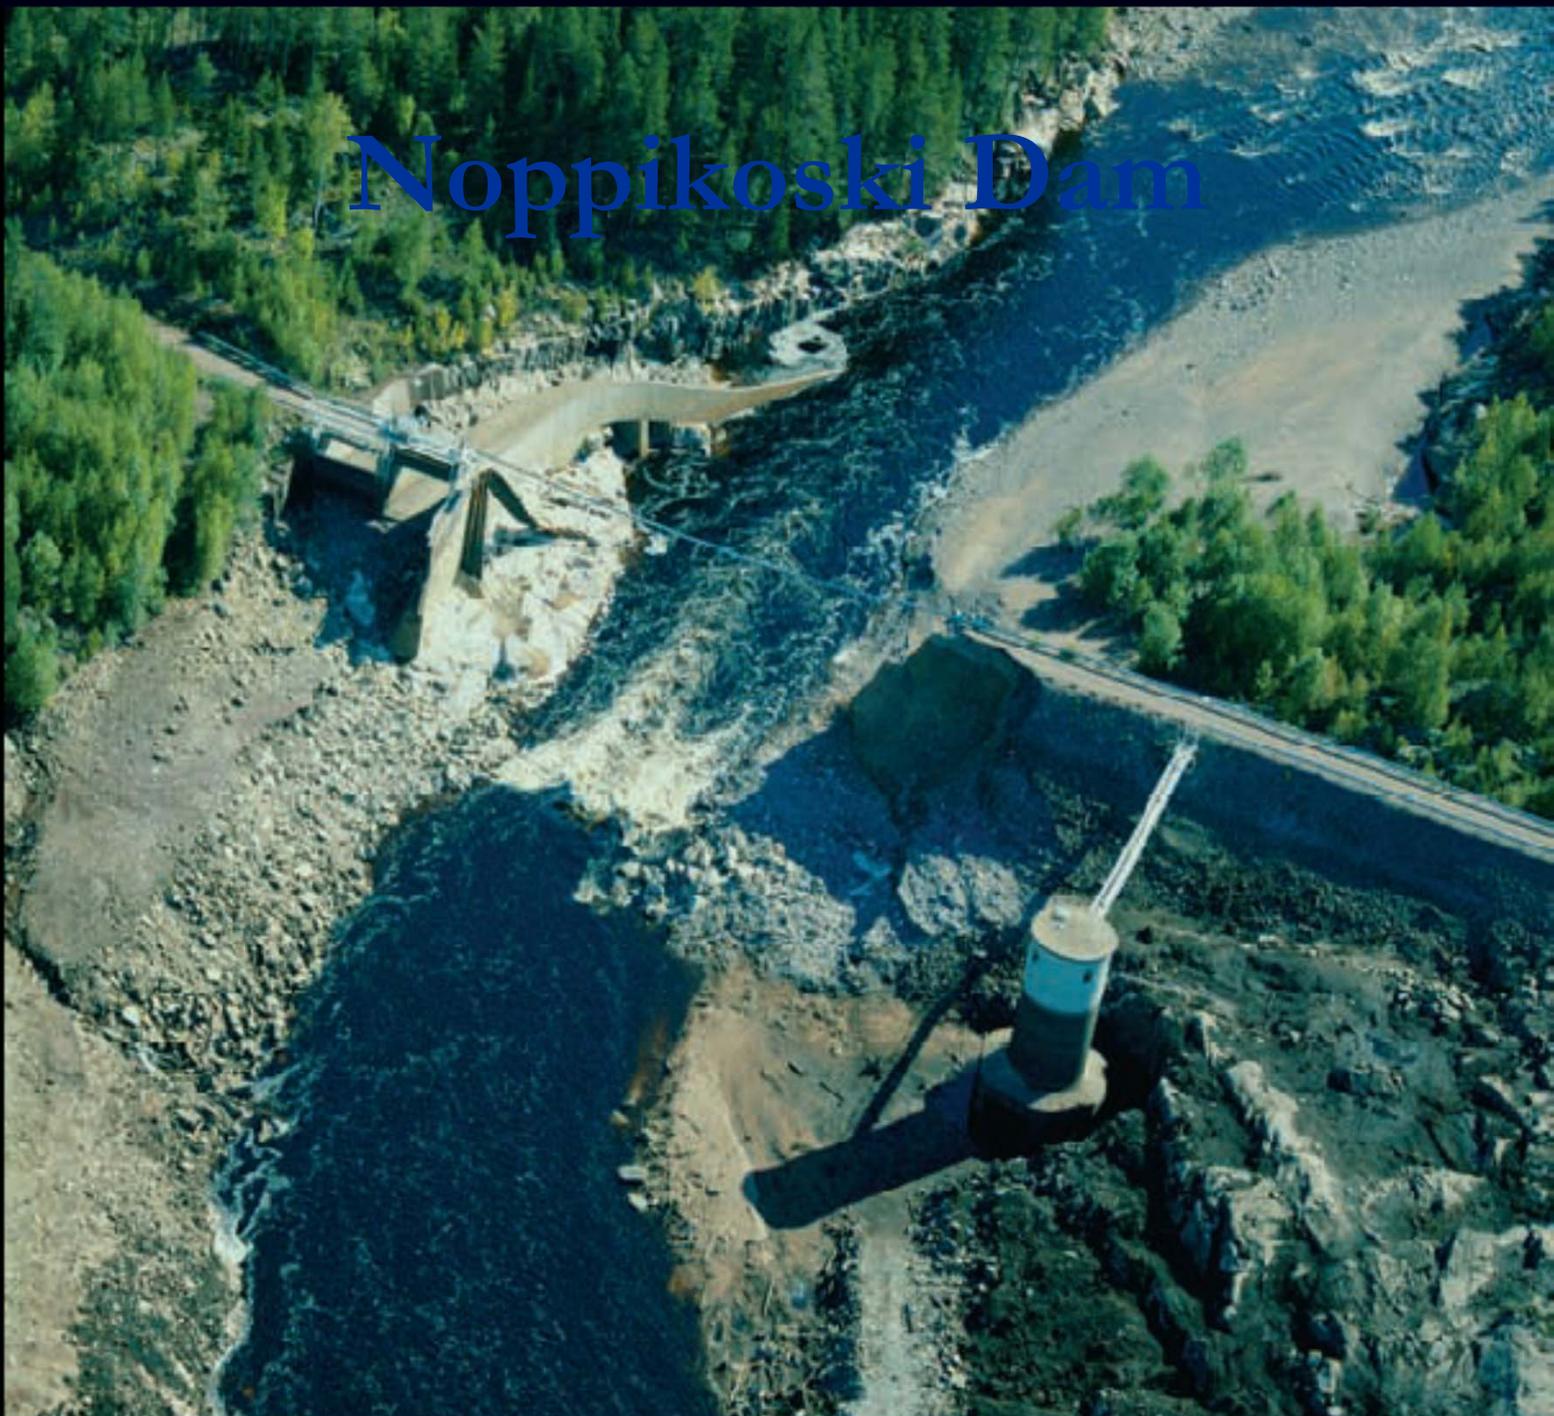
# Noppikoski Dam

- Operators tried to raise the embankment sections along the sides of the spillway with no success and the dam overtopped and failed.
- Luckily, the downstream residents had been warned and there were no fatalities.

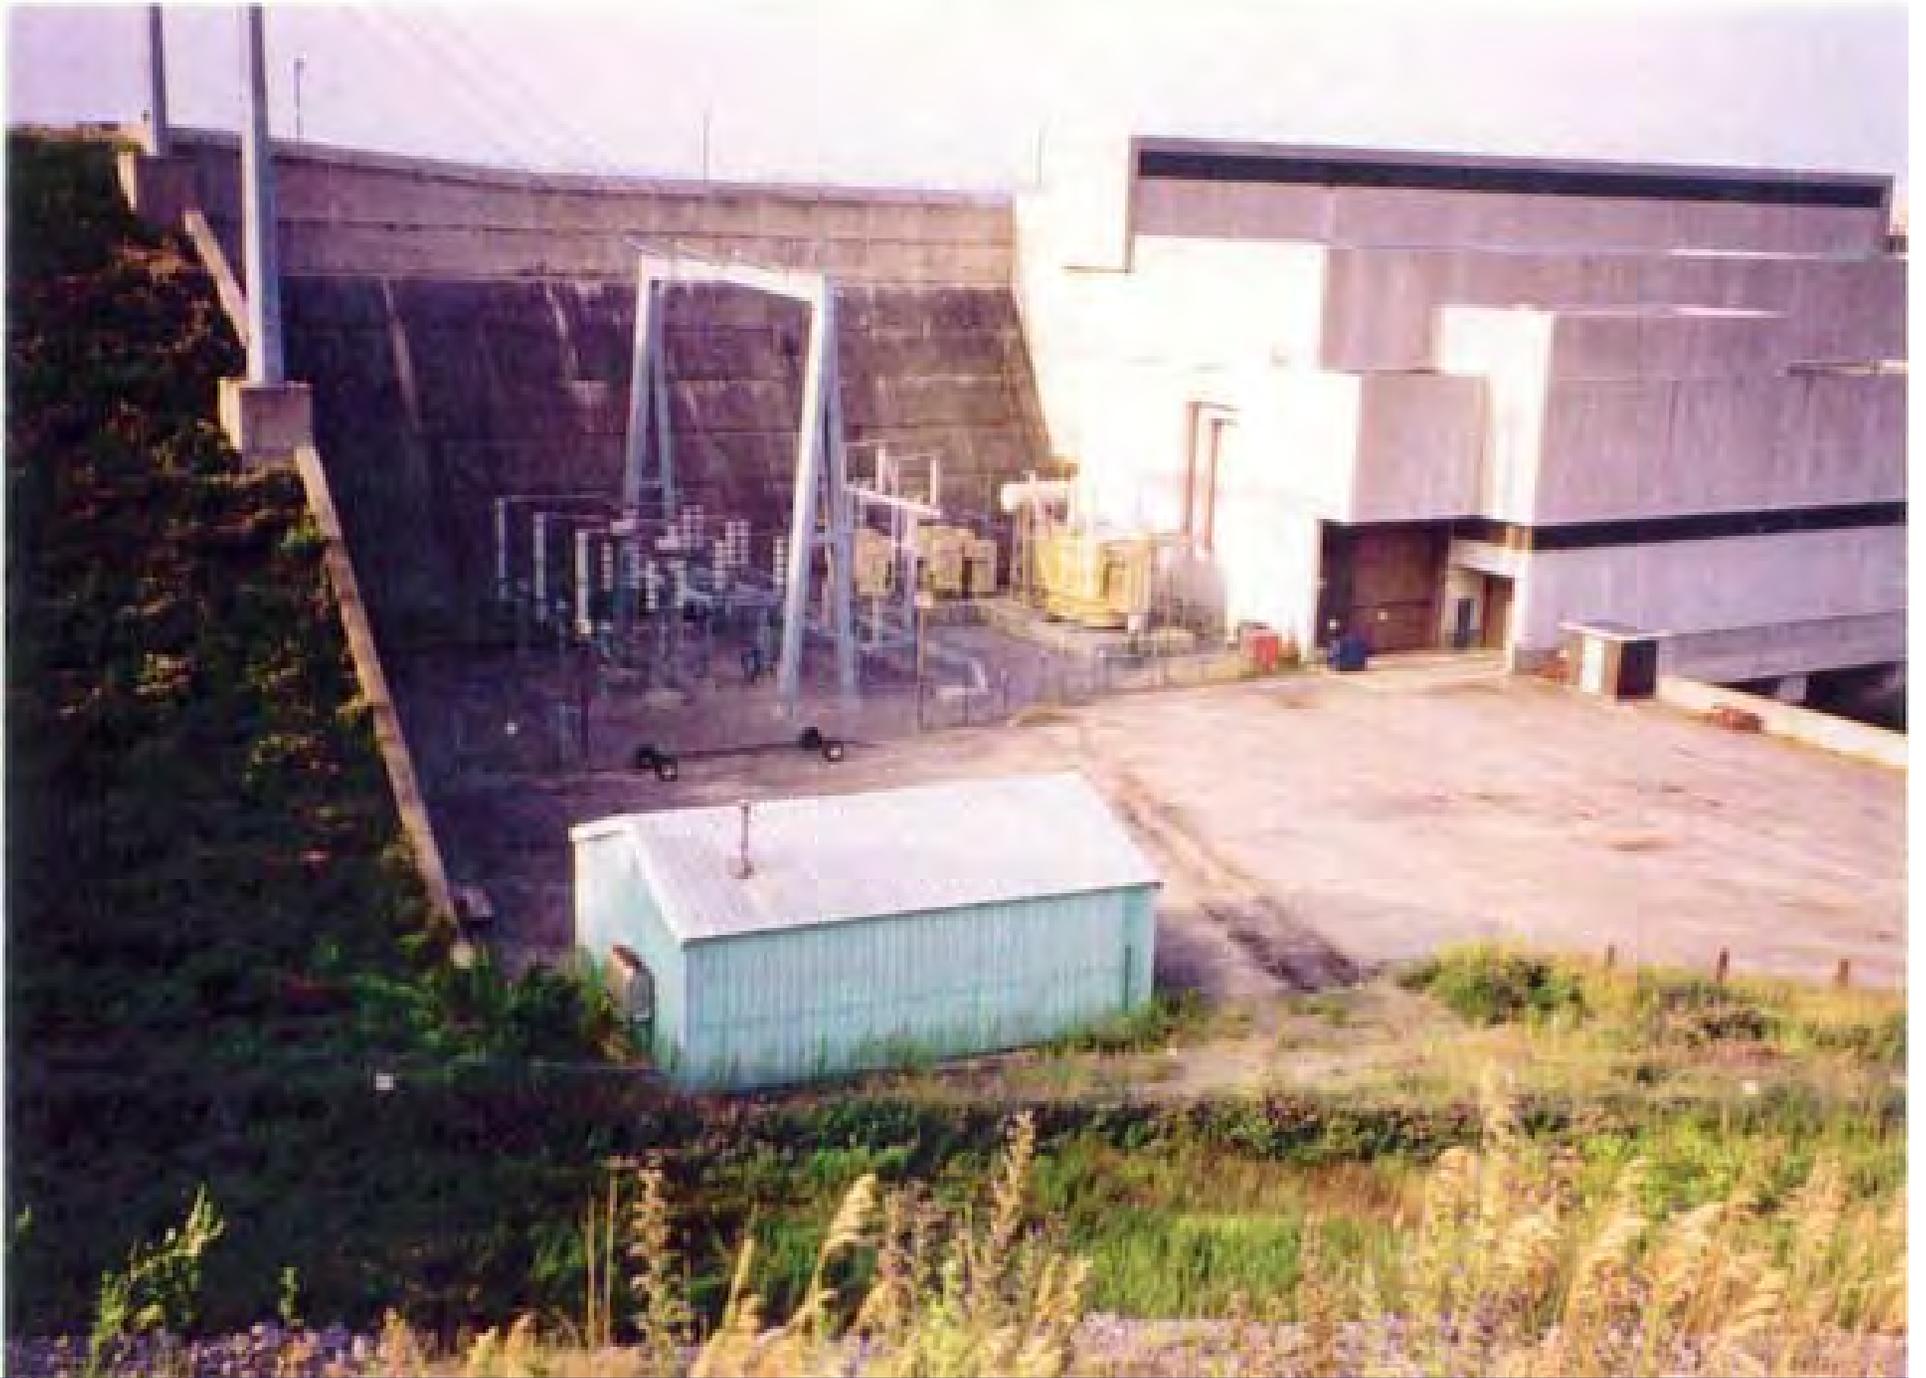
- Limited amount of overtopping flow (no structural concern) may result in effects which reduce discharge capacity and result in major overtopping and potential failure
  - knock out transformers to plant
  - take out power supply to gates
  - prevent access to gates

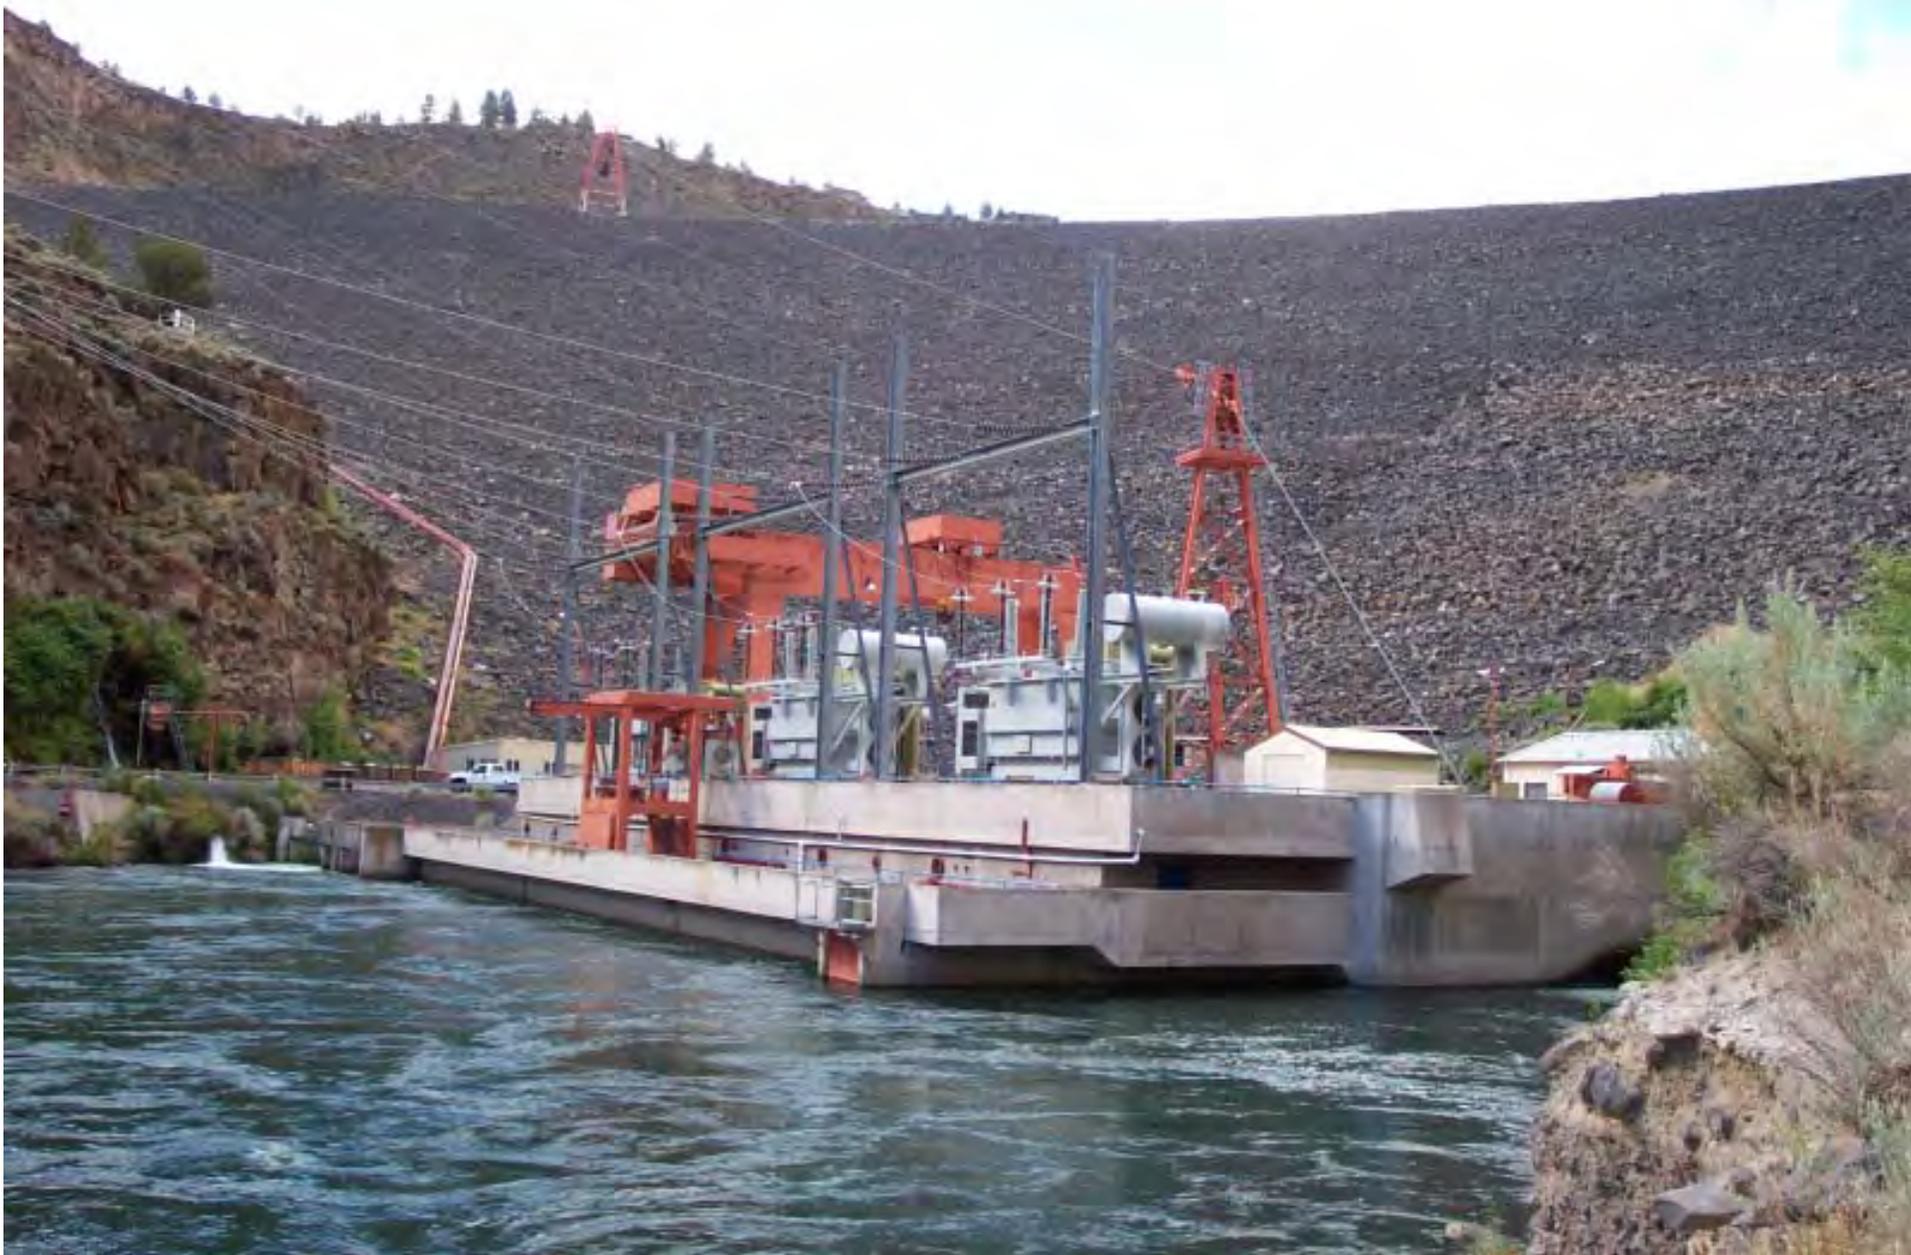
- Flow through powerhouse is necessary to pass PMF
- Powerhouse has a design feature whereby the turbines are “blocked” to prevent rotation while flow passes through the units.
- Field assumed headquarters would make call to block turbines. Headquarters assumed field knew when to do it.
- SOP developed so all know who makes call and when.

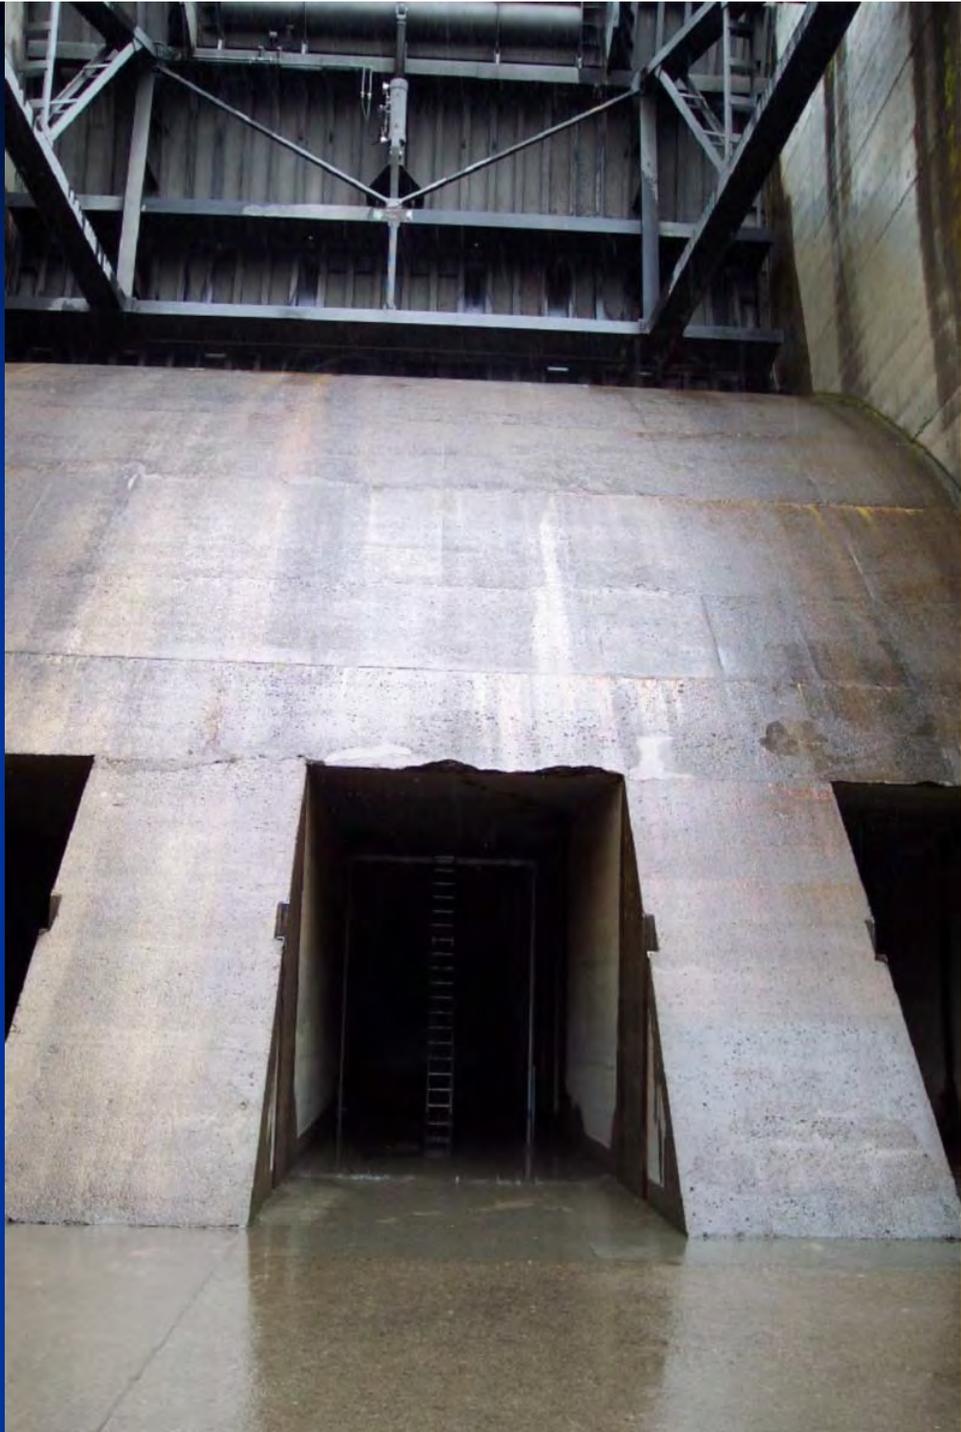
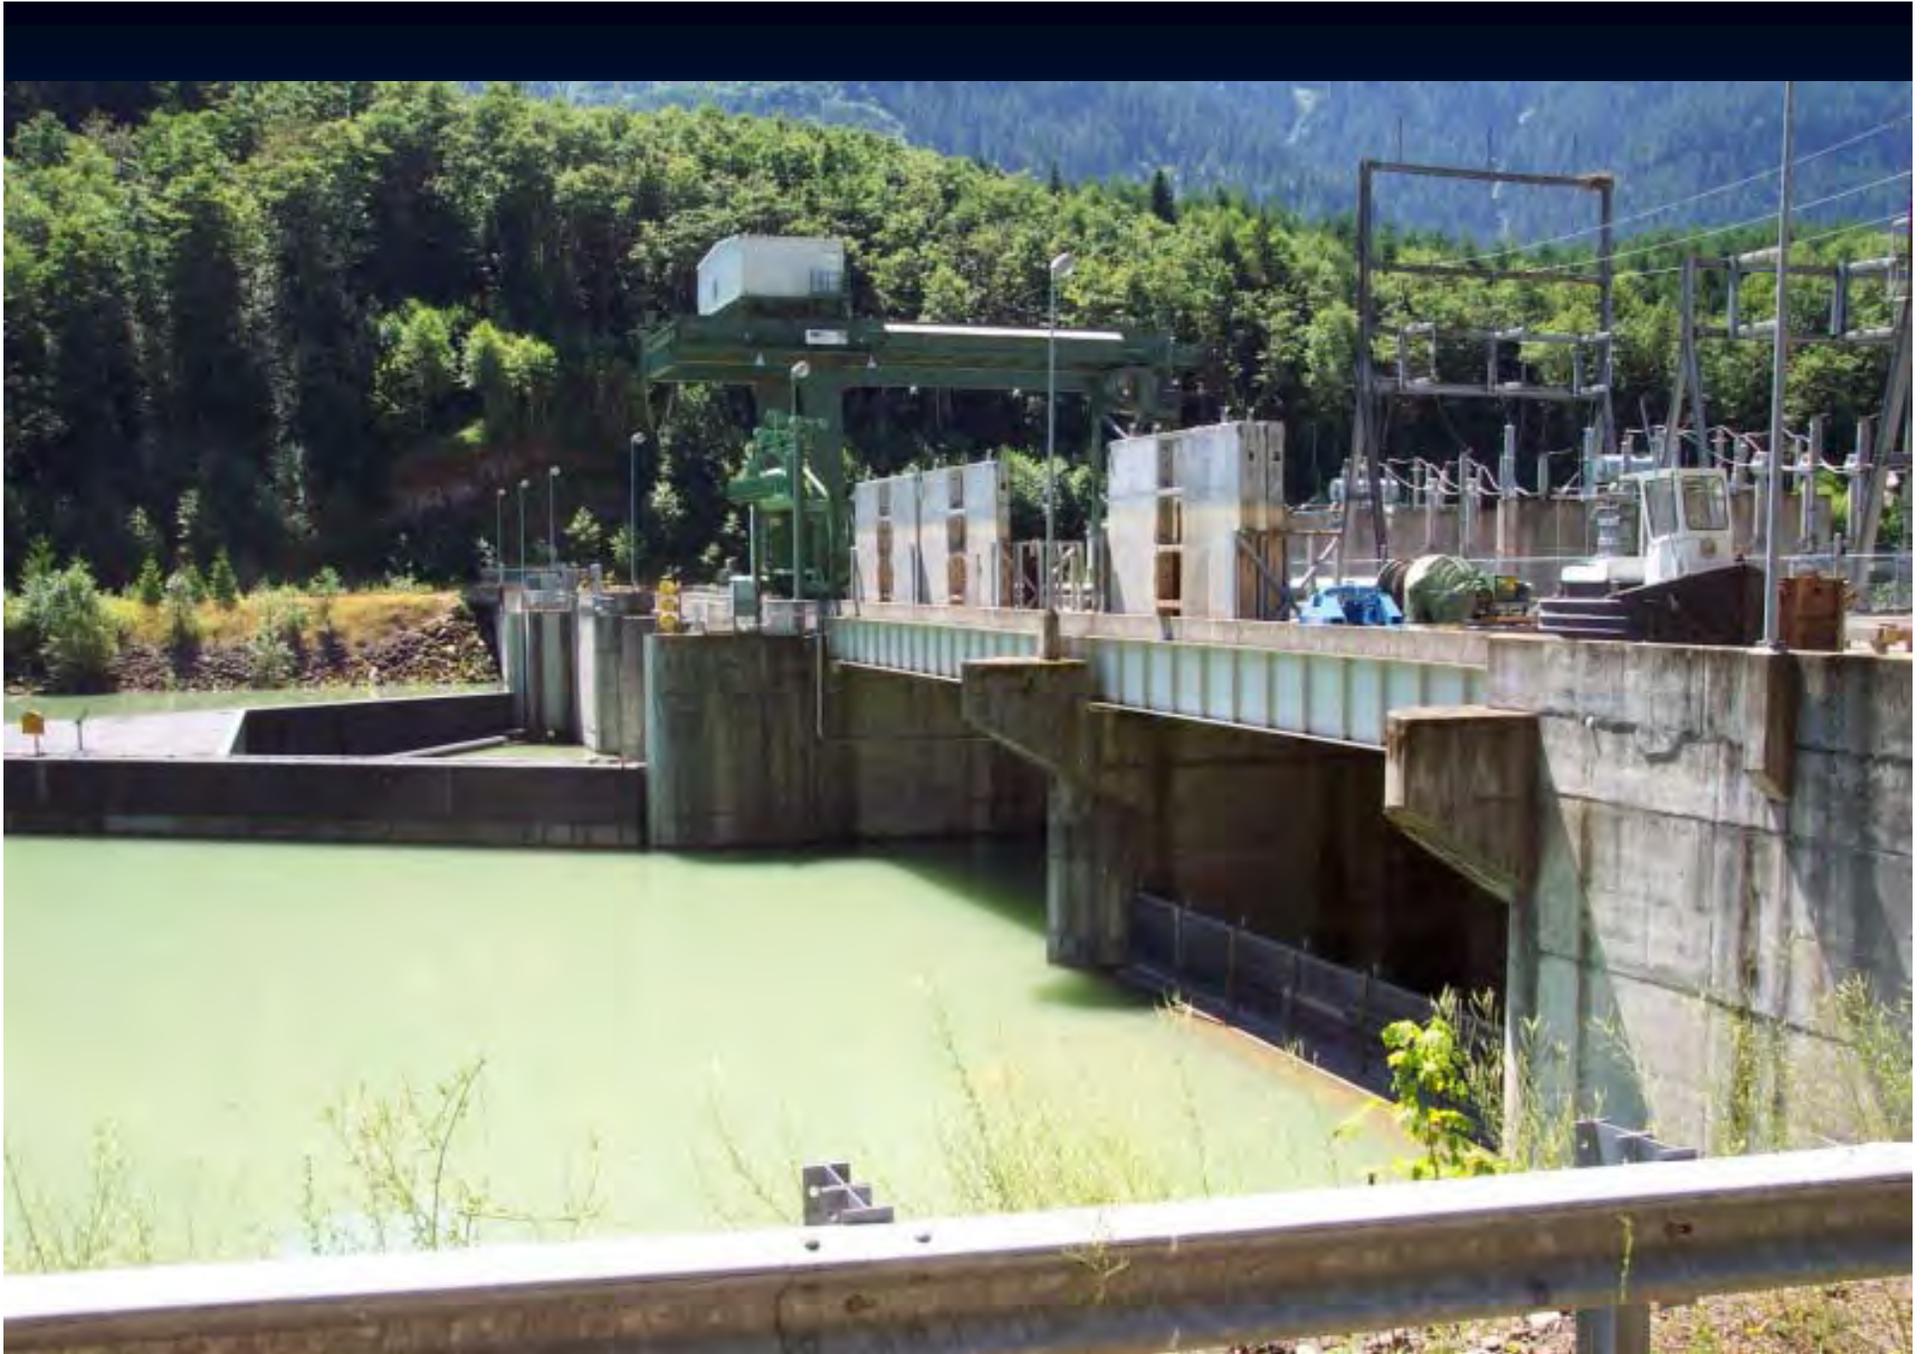
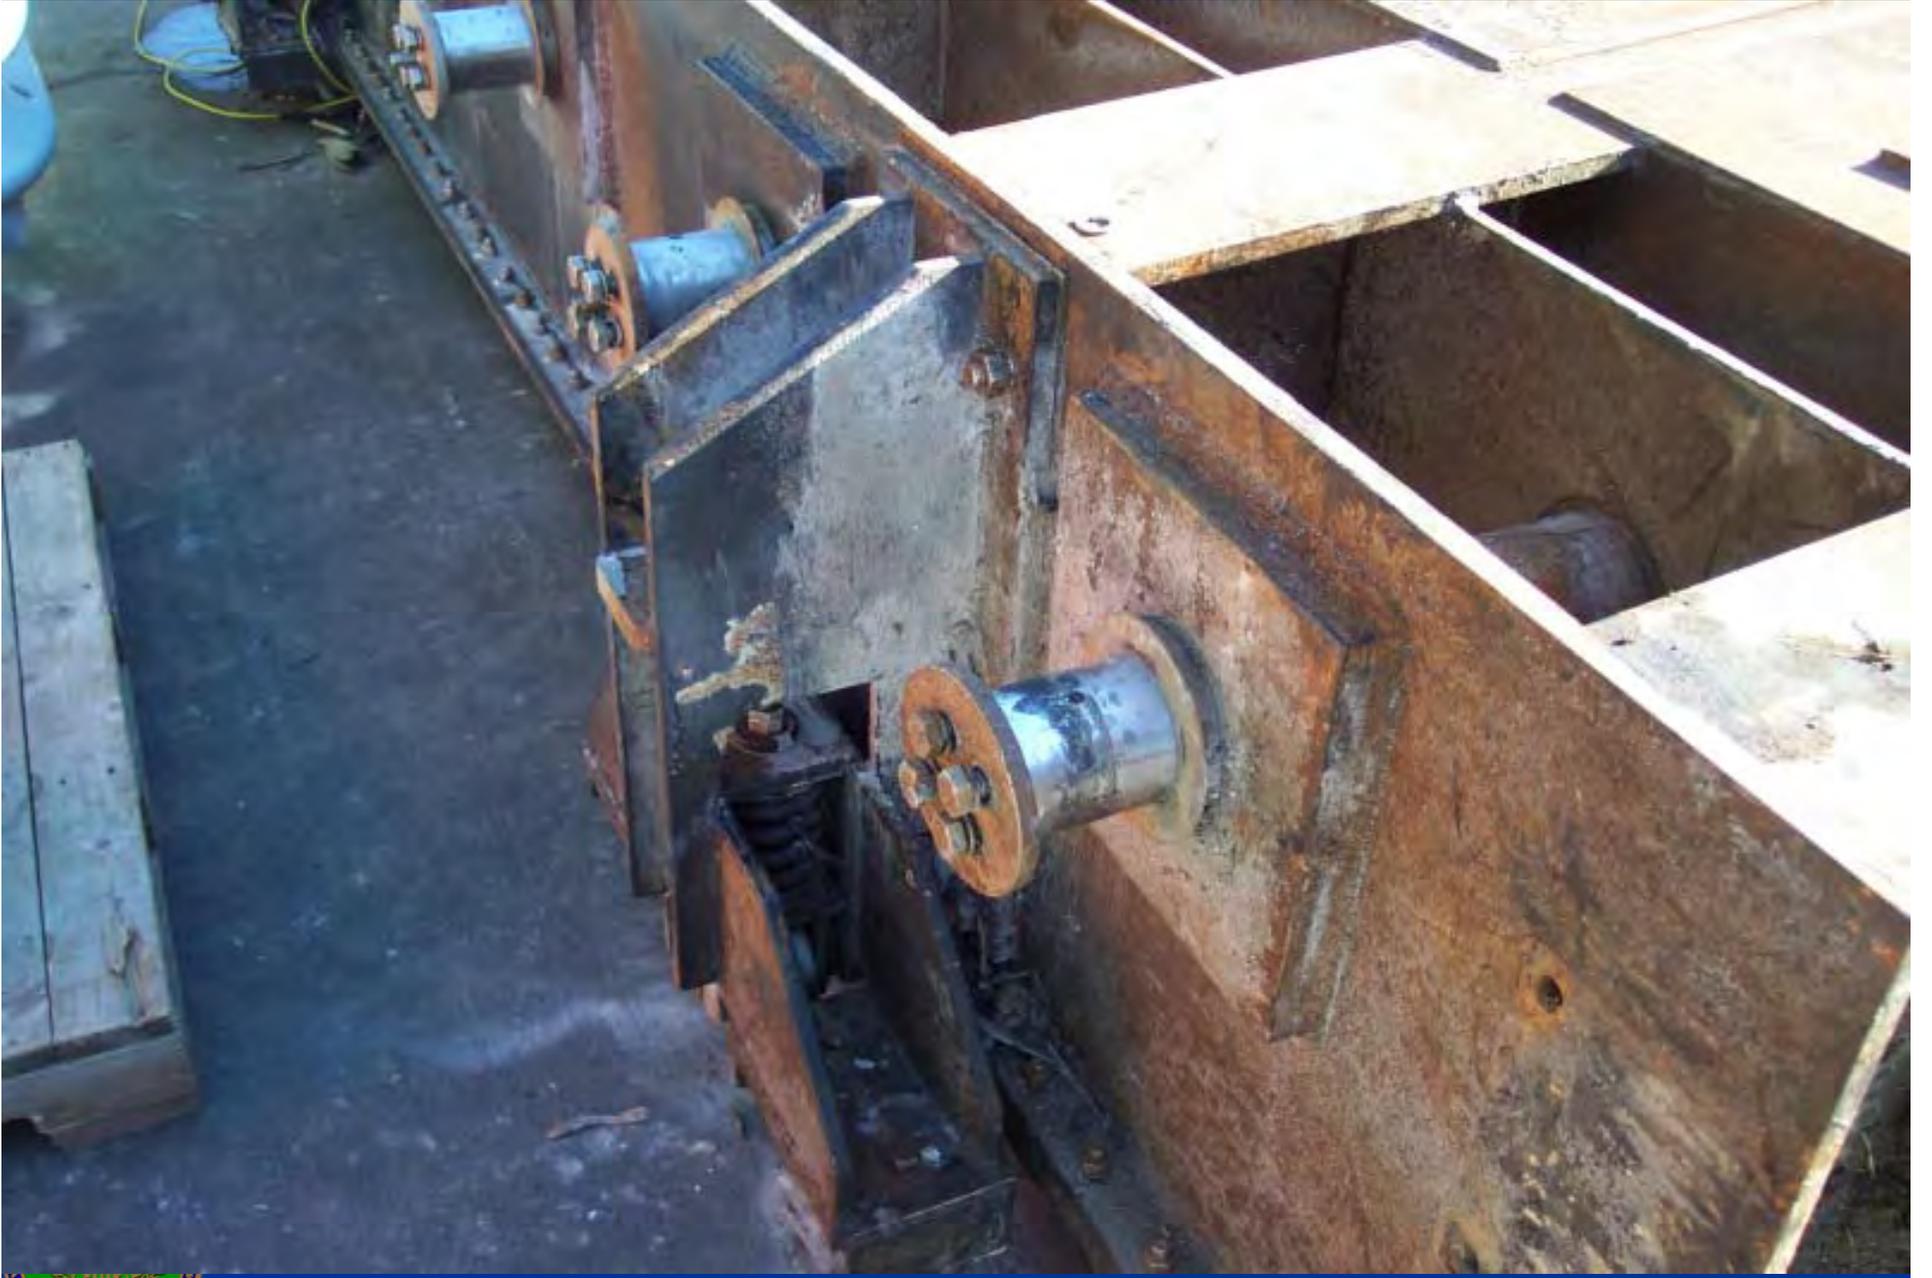
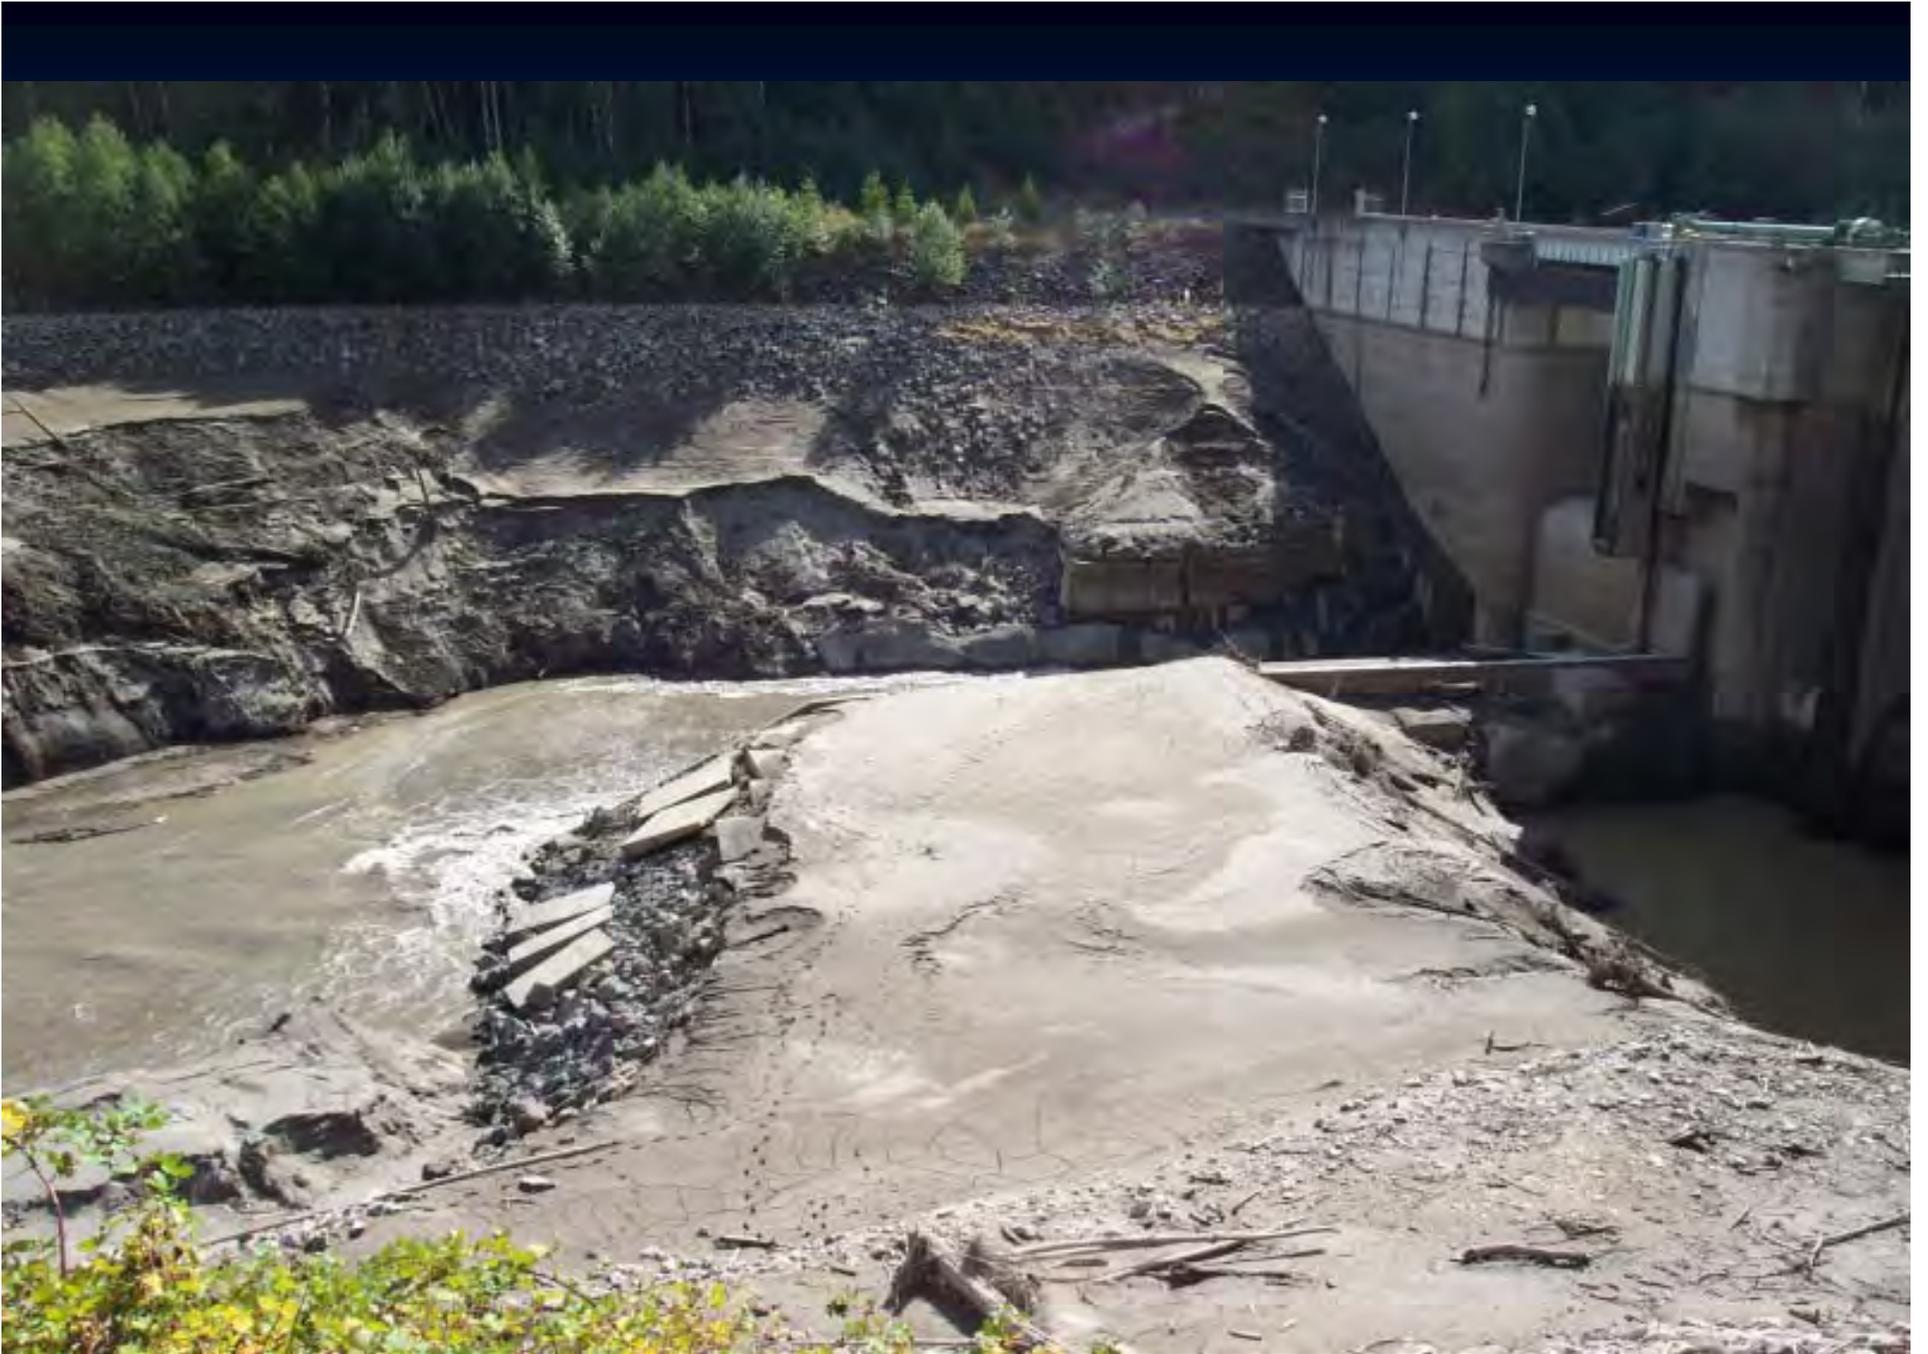
- Dam is designed with spillway flows passing over low level outlets
- SCADA system is designed to NOT allow spill when low level outlets are open due to excessive vibration of open gates
- SCADA system fault allowed gate operation. Also bypassed a limit switch intended as “fail safe” backup
- Excessive vibration damaged gate to extent it would not close resulting in draining reservoir

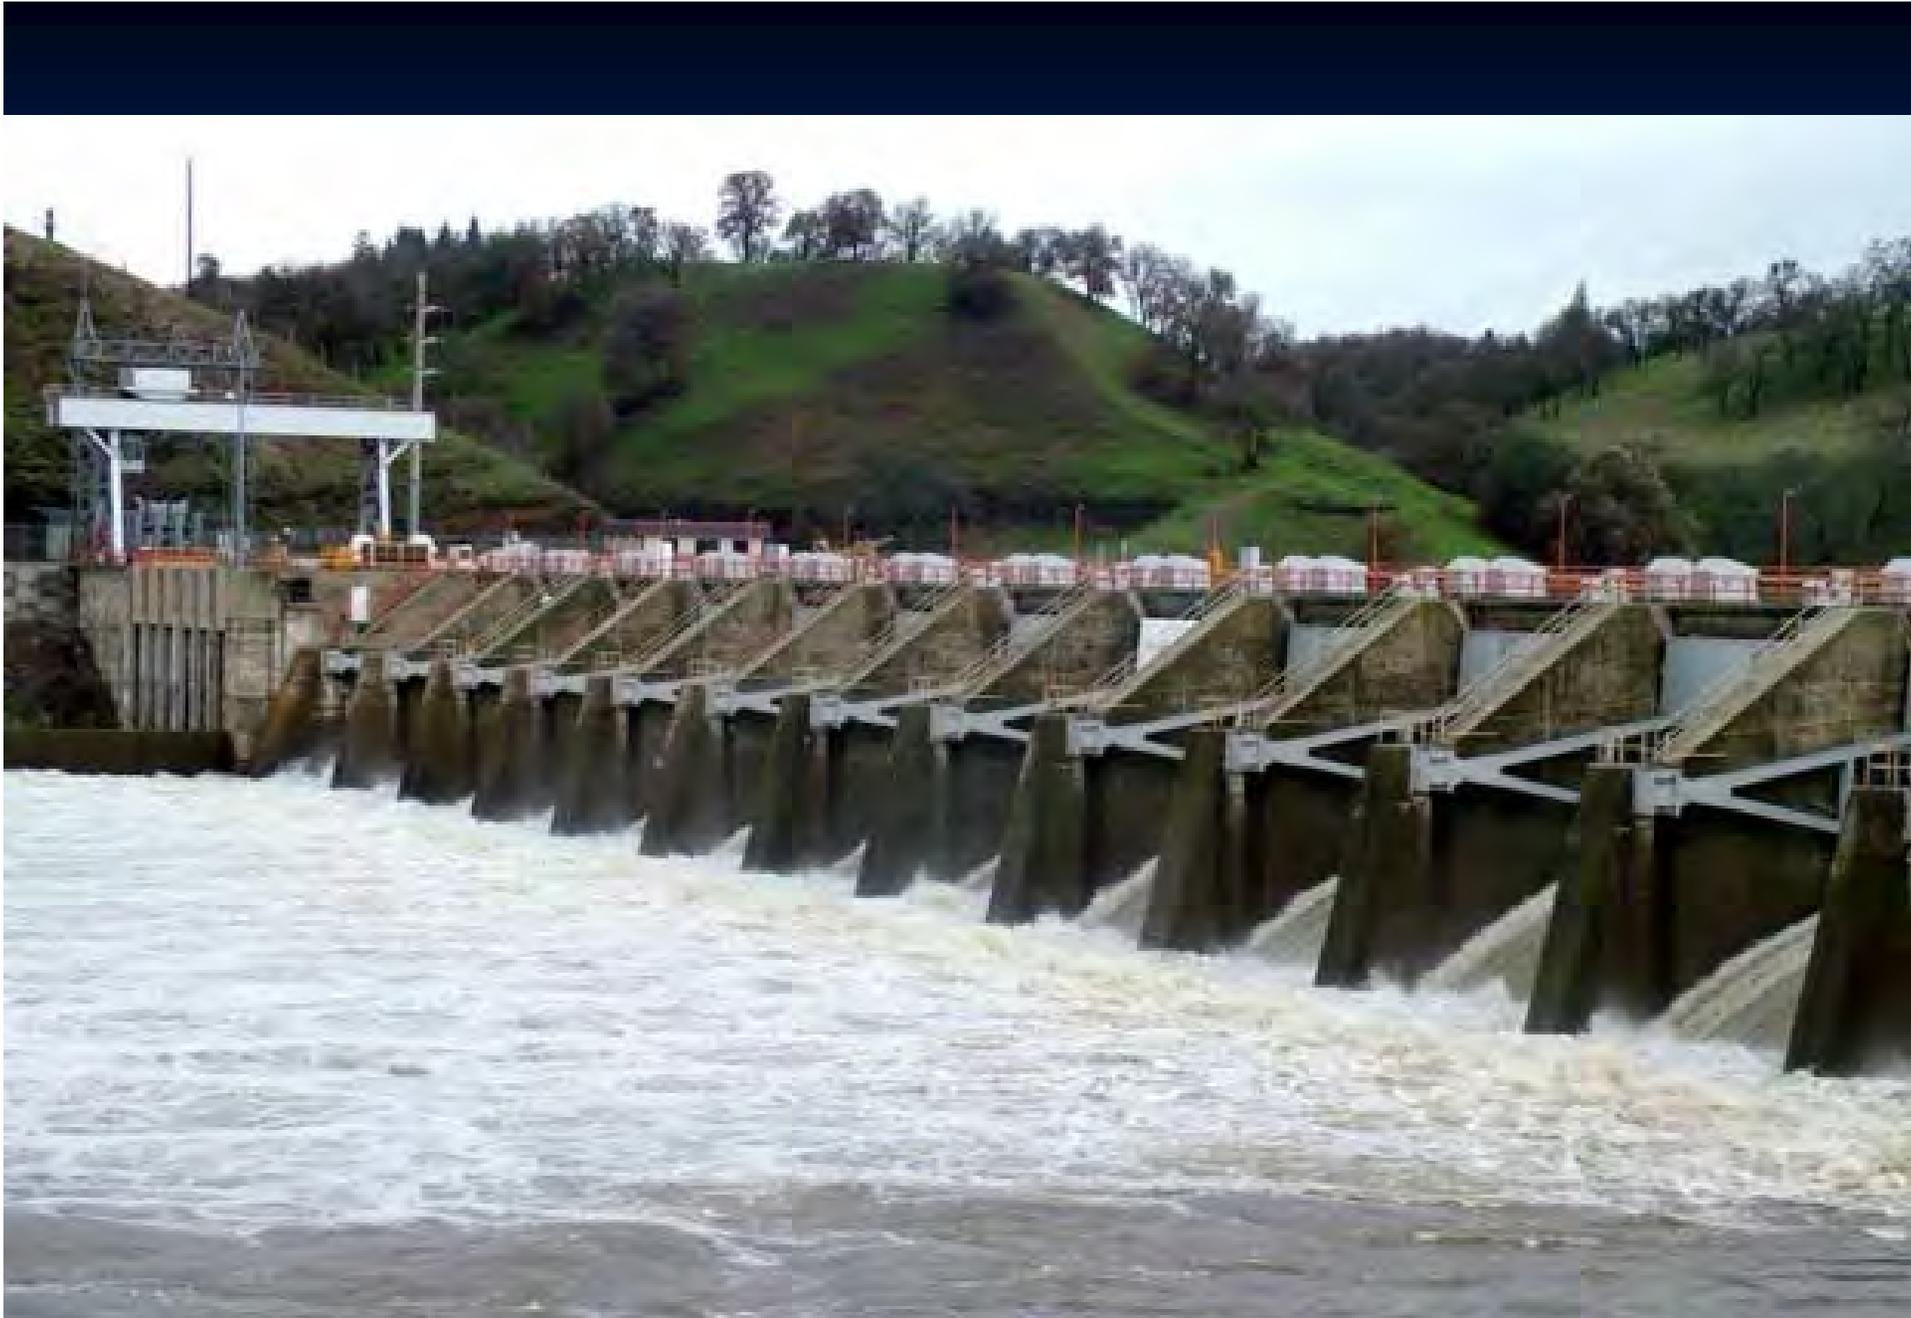
- During gate operations, a failed position sensor allowed the gate to raise more than intended.
- Vibrations during prior gate operations apparently caused the connection to fail.

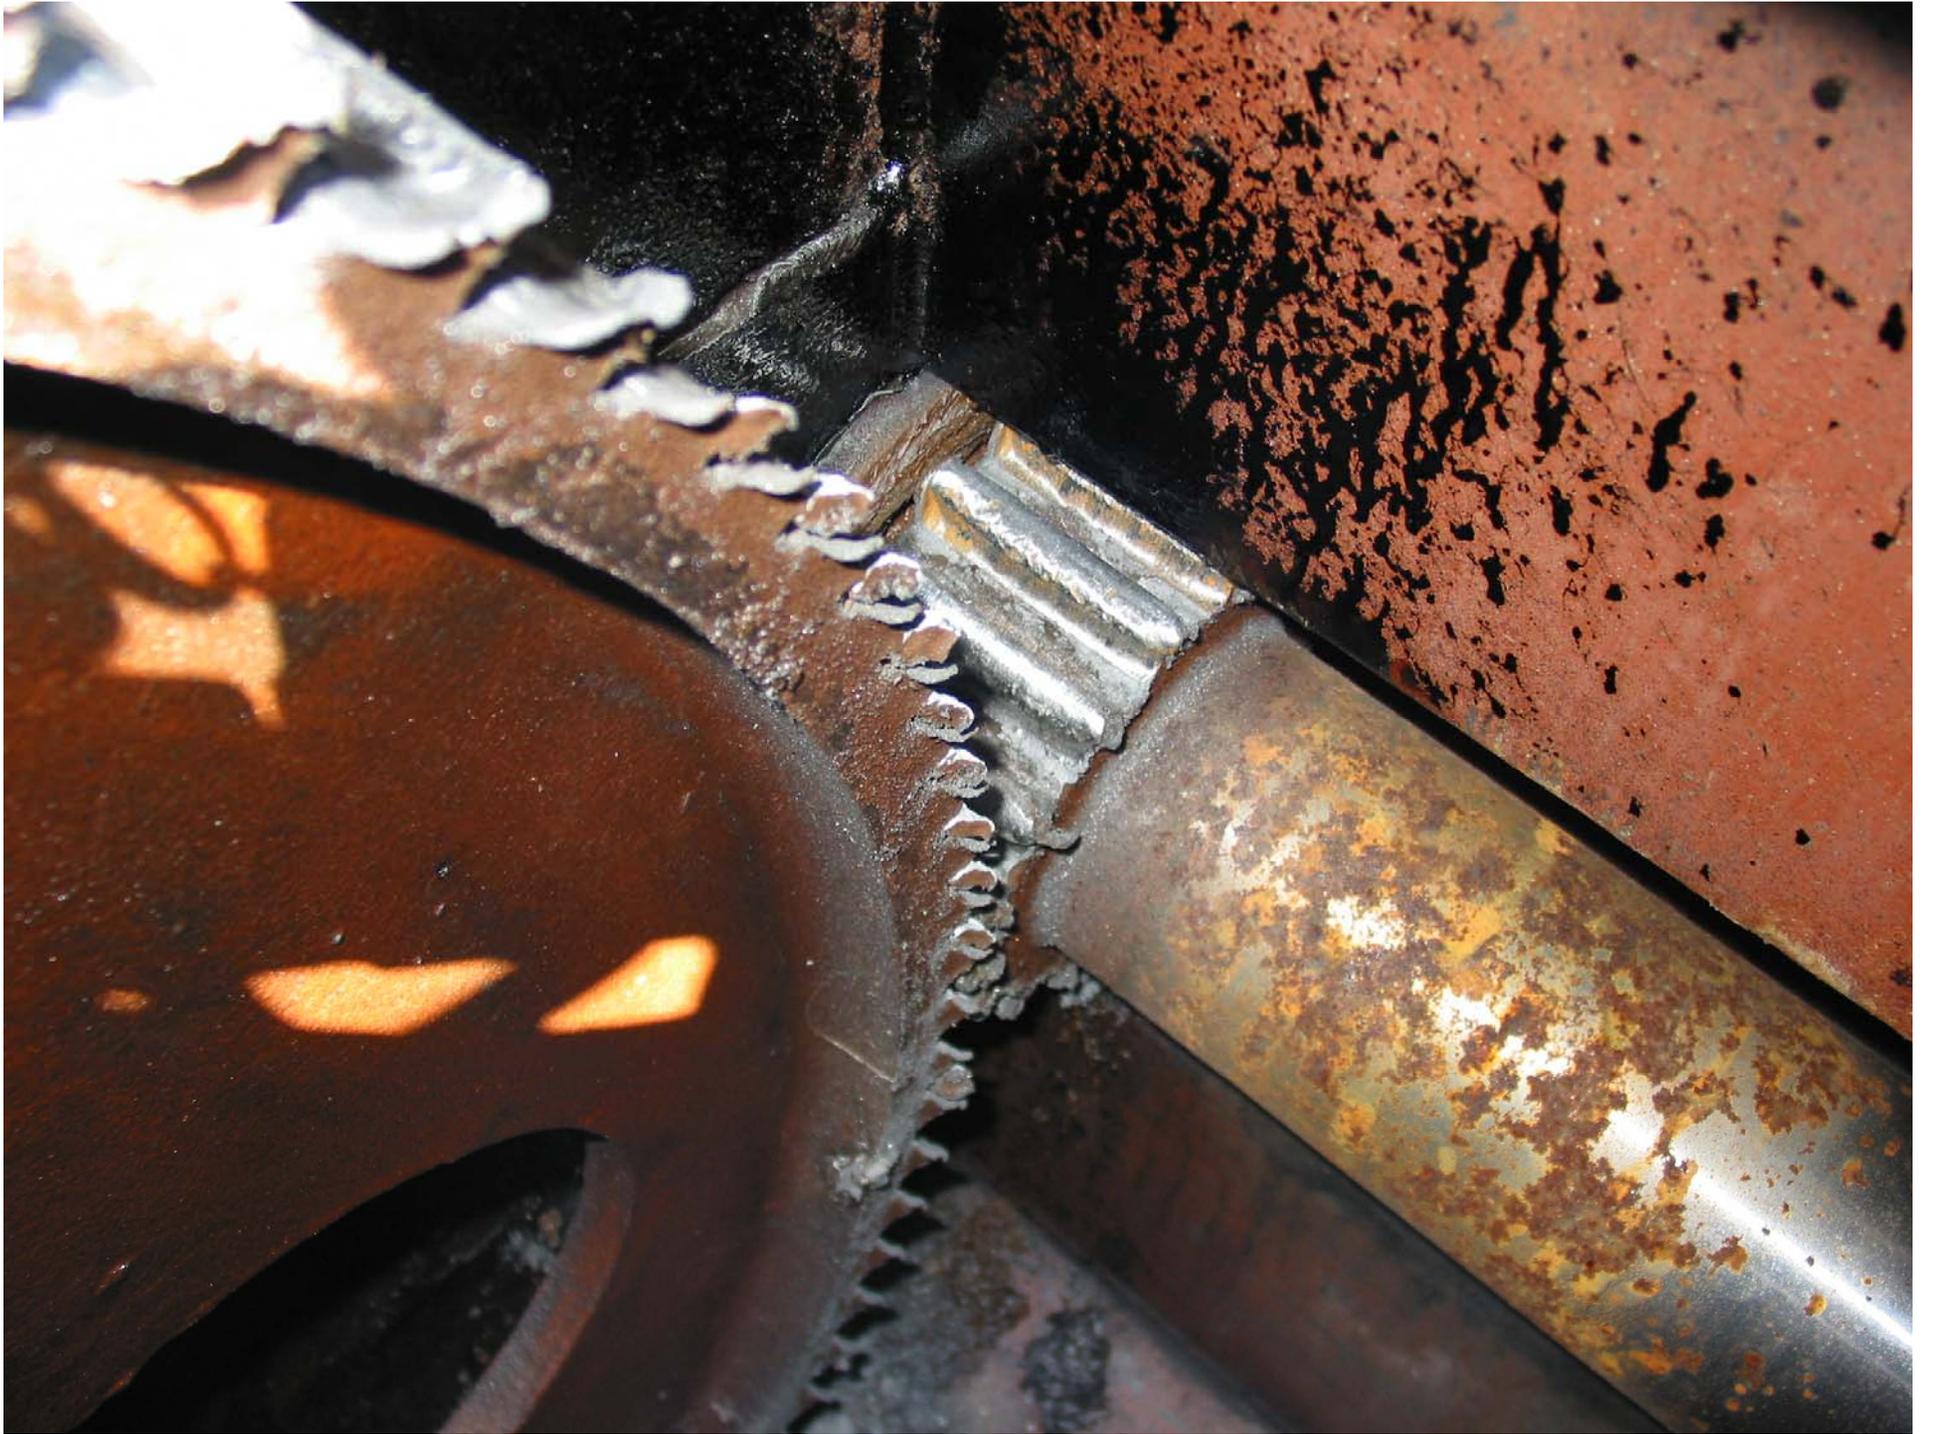
- Change in gate operations from a few times a year to daily (for fish passage)
- Lubrication schedule remained the same.
- Gearbox stripped, gate dropped on one side
