# Operational Failure Modes

# Noppikoski Dam

# Sayano-Shushenskaya

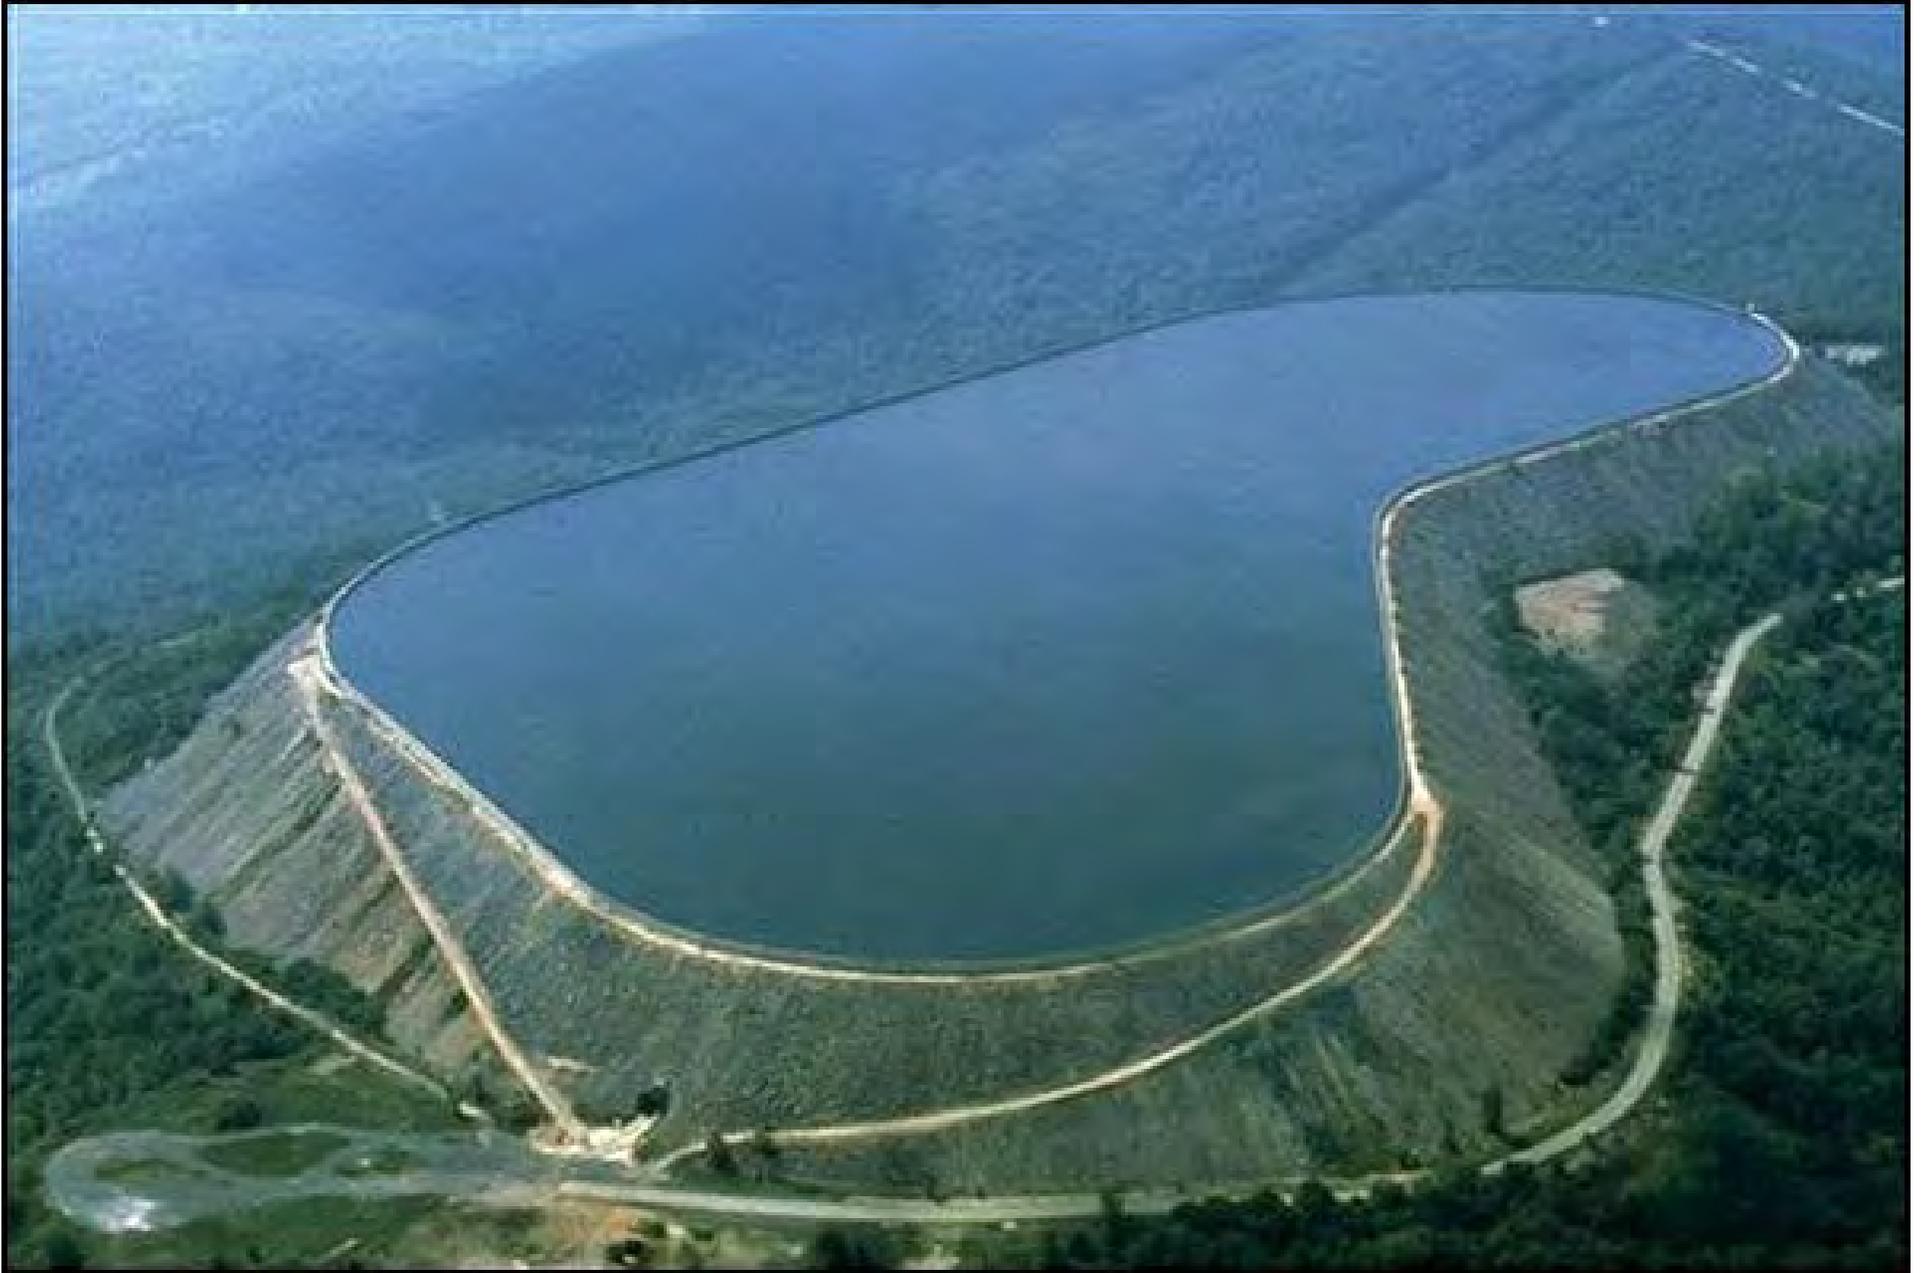
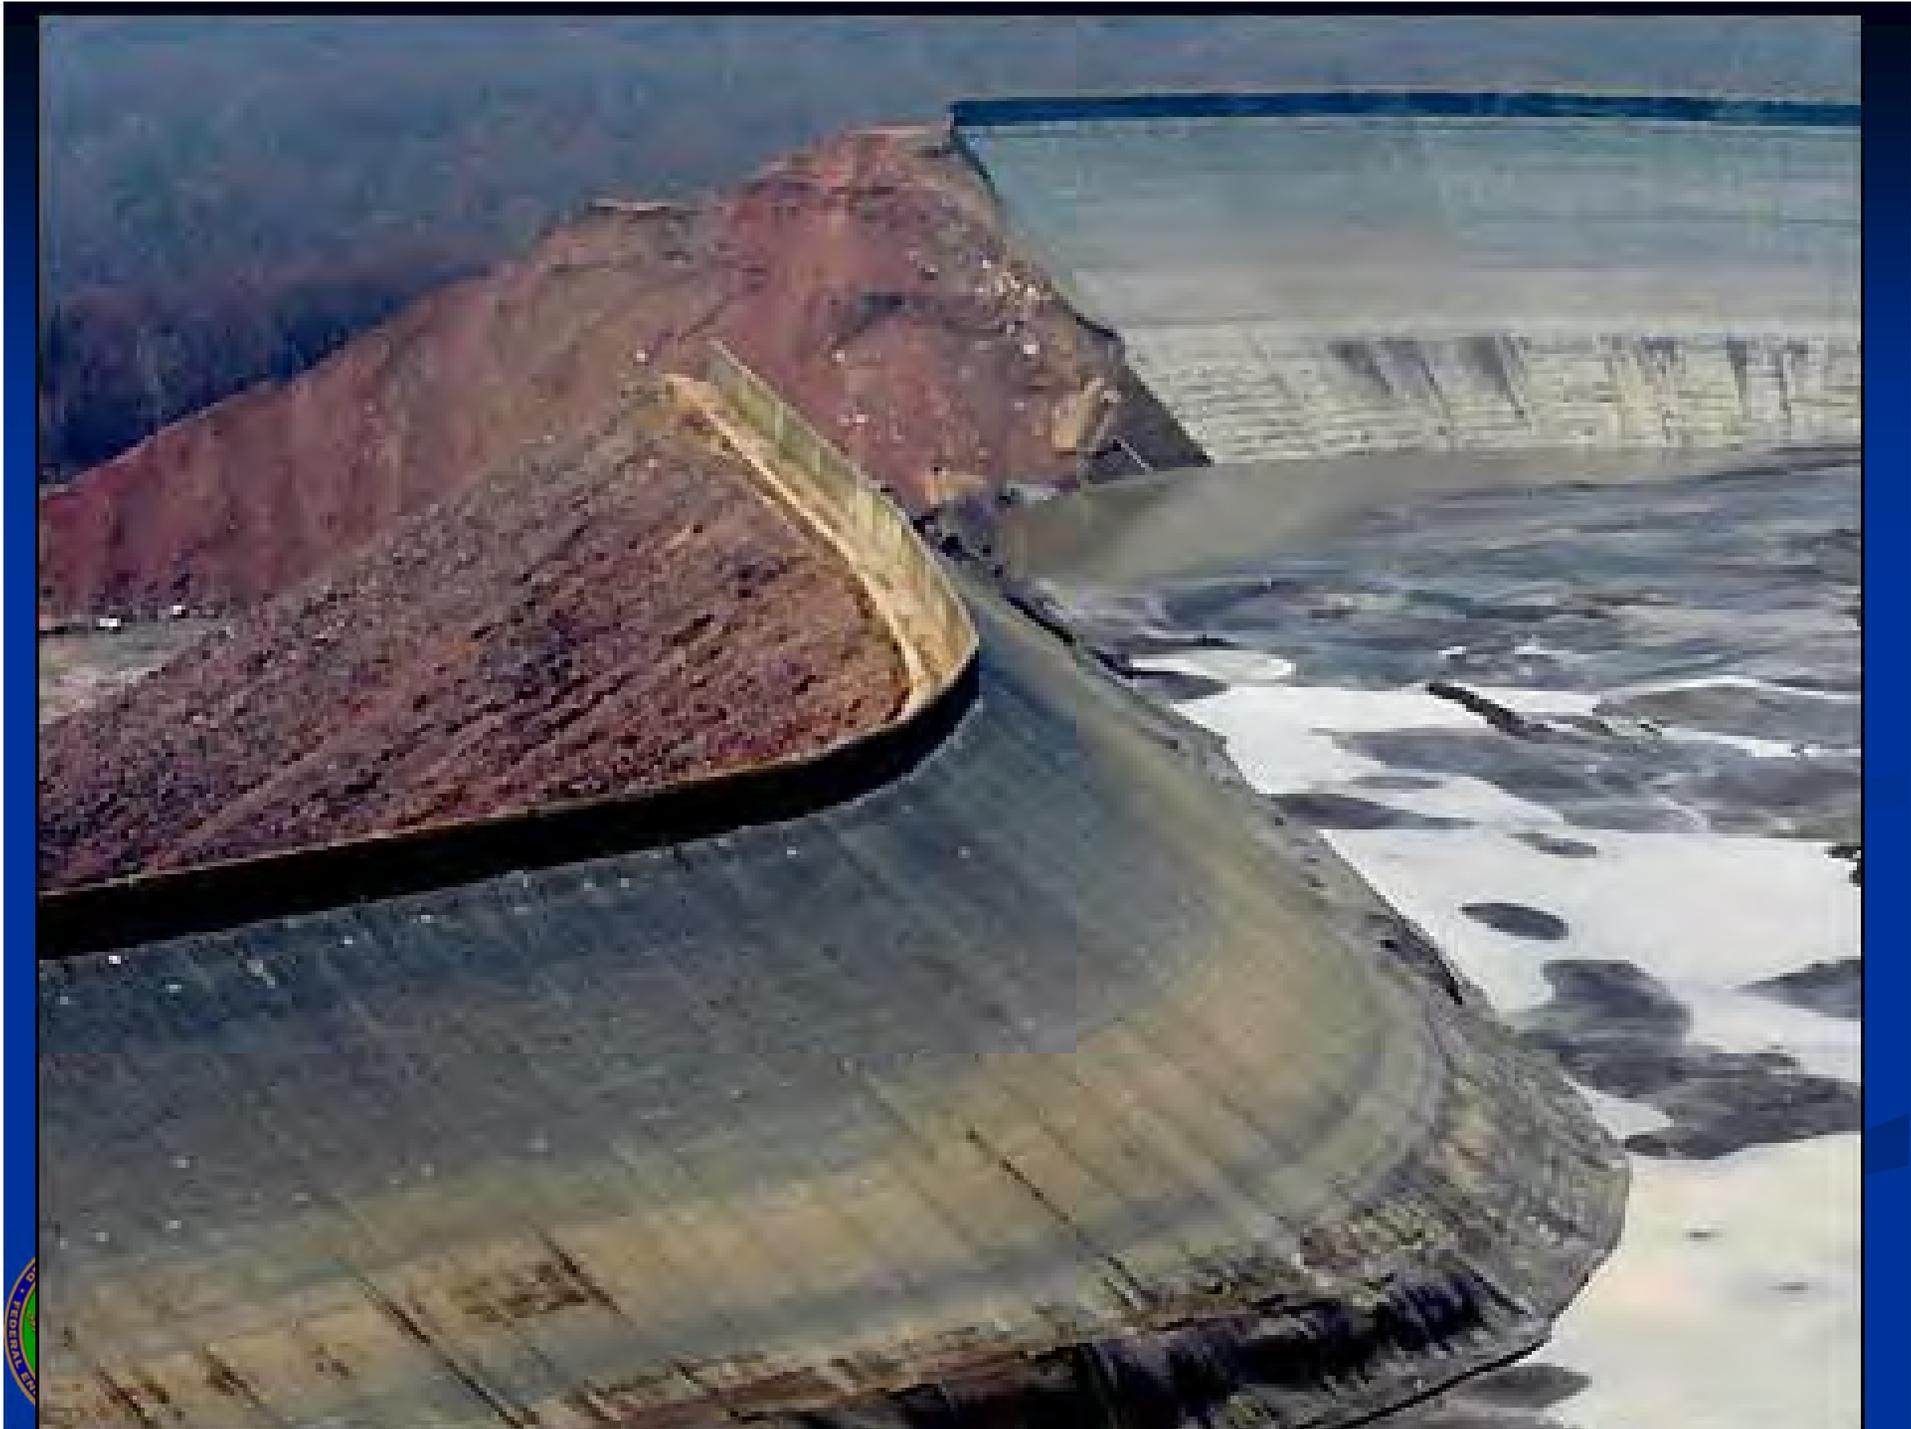
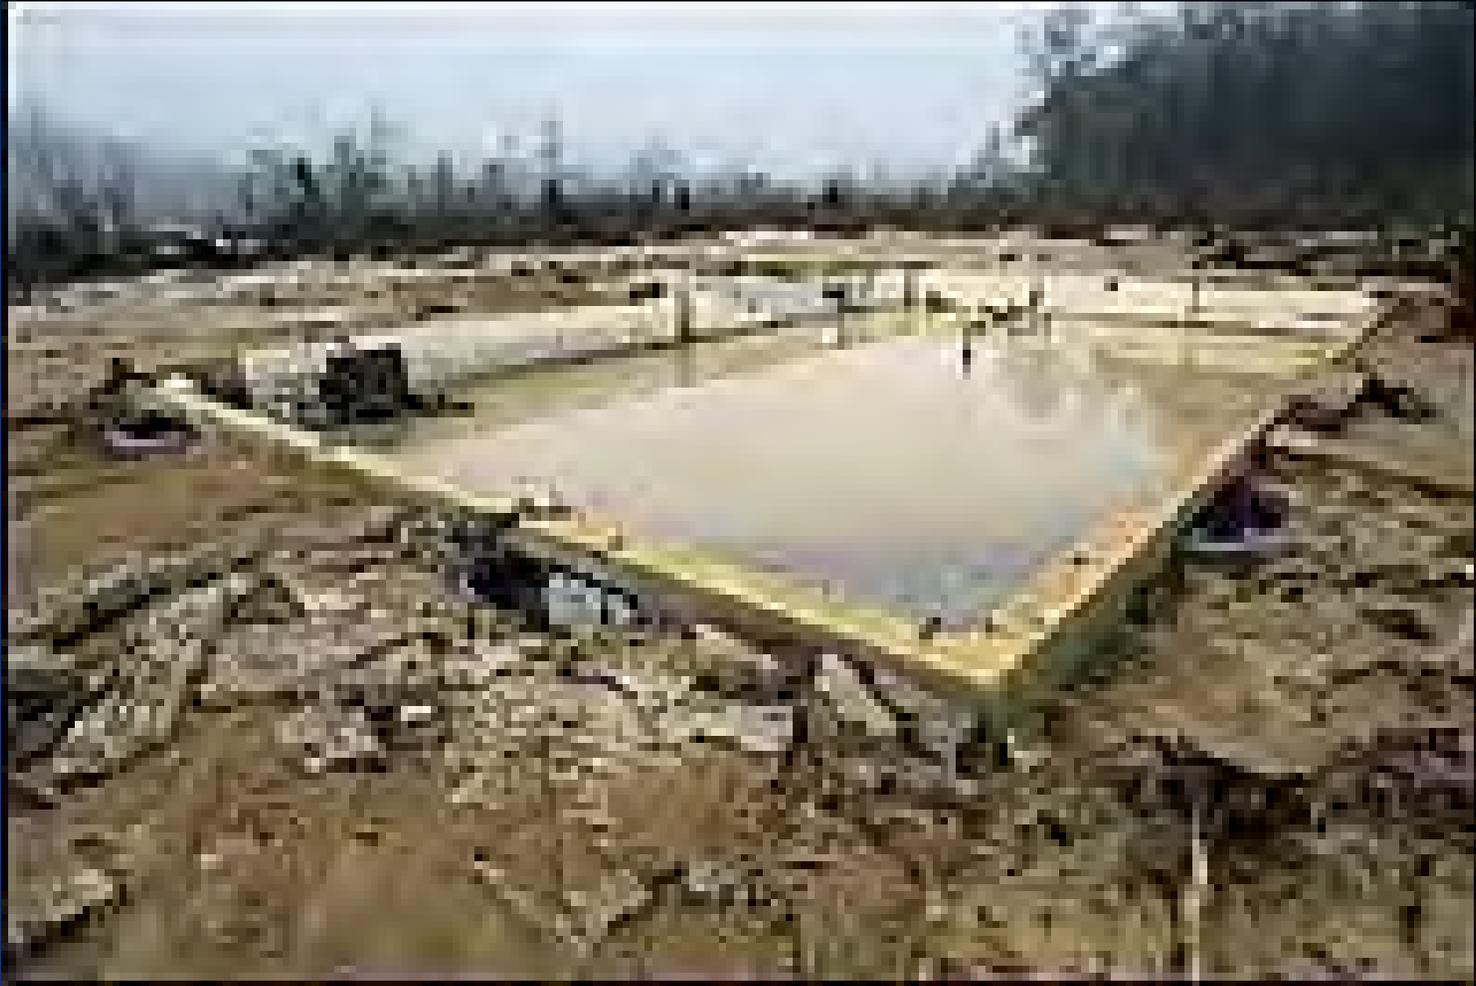
- Over-pumping of the upper reservoir of a pumped storage project to overtop and fail.
- Many contributing factors
  - Settlement of parapet wall
  - Failure of anchoring system for water level sensors
  - Rewiring of high water alarms effectively cutout alarms

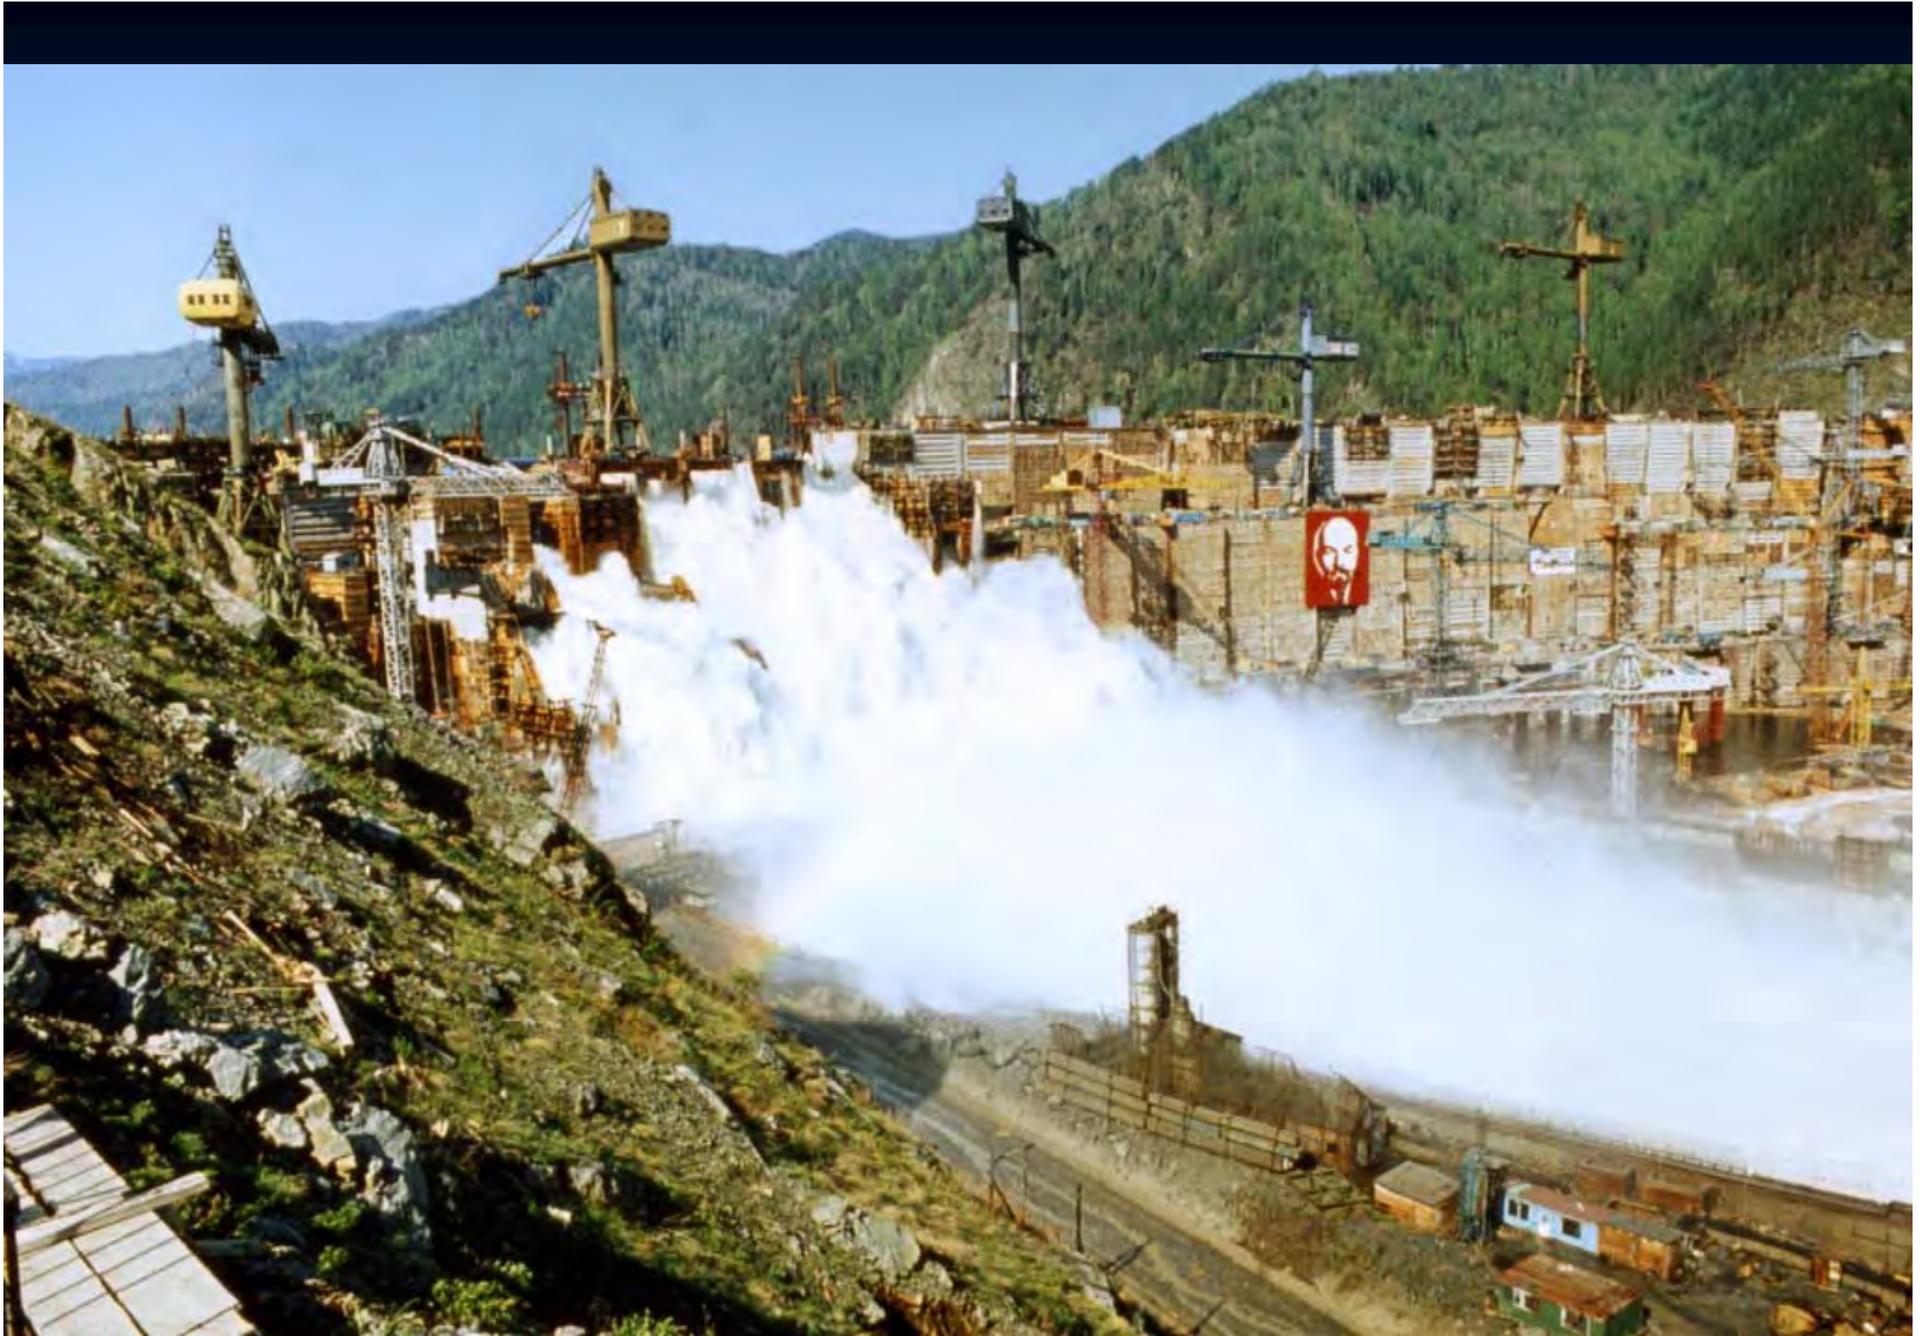
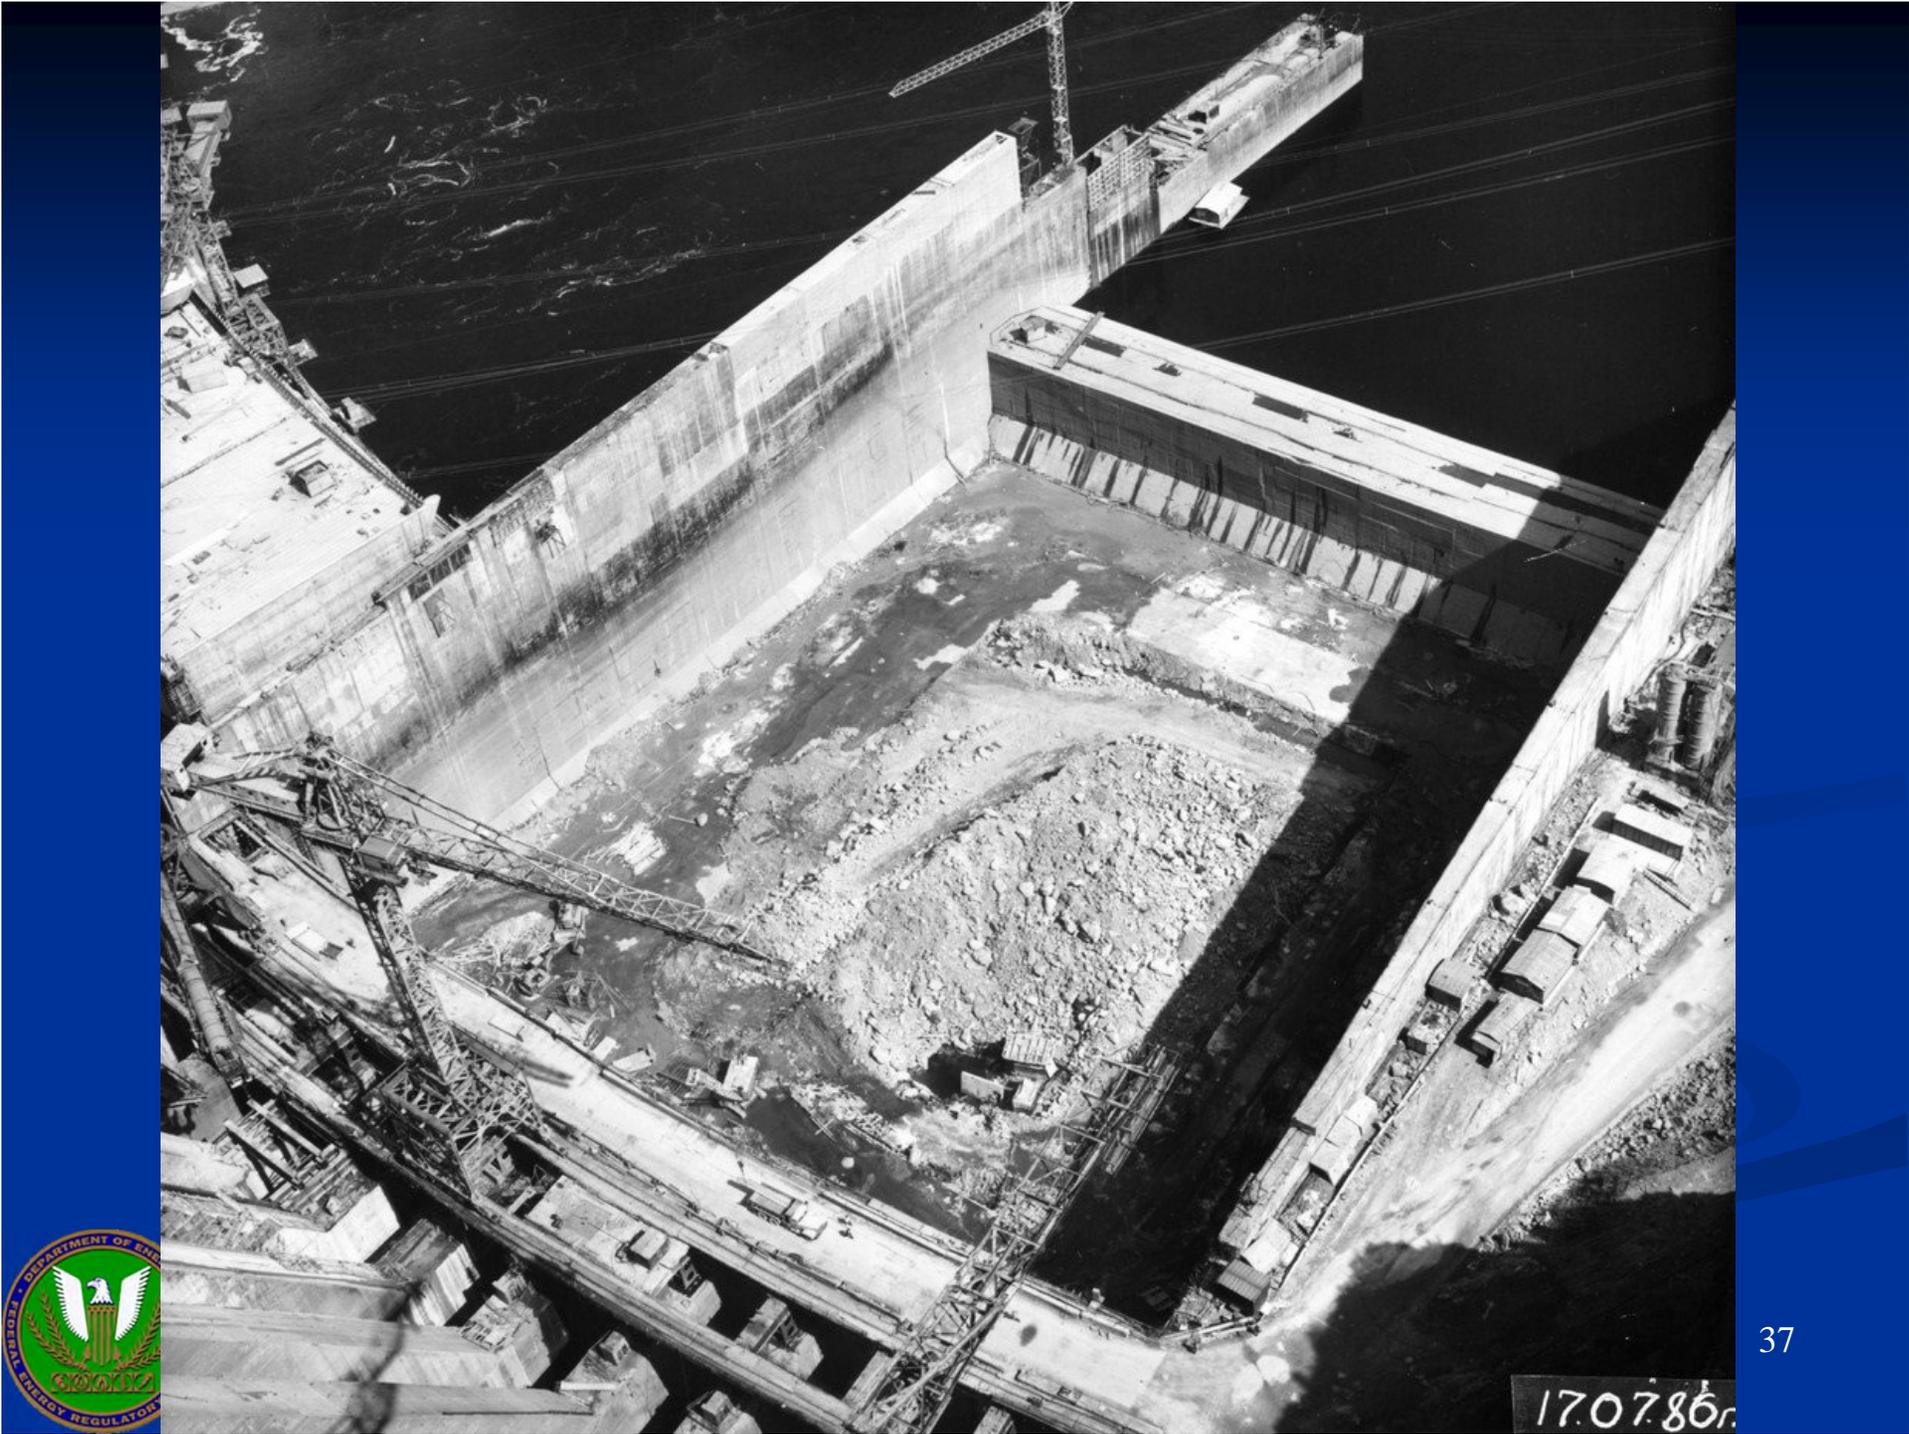
17.07.86

- During construction the spillway was used to pass water
  - During construction a flood resulted in 4500 m<sup>3</sup>/s being discharged through the spillway
  - The spillway stilling basin was severely damaged while passing 4500 m<sup>3</sup>/s - 7m of the foundation was eroded
  - The flood also overtopped the partially constructed dam cracking the dam-foundation interface and some concrete monoliths
- The damage to the spillway was repaired
