UTILITY VEGETATION MANAGEMENT AND BULK ELECTRIC RELIABILITY  
REPORT FROM THE FEDERAL ENERGY REGULATORY COMMISSION

SEPTEMBER 7, 2004

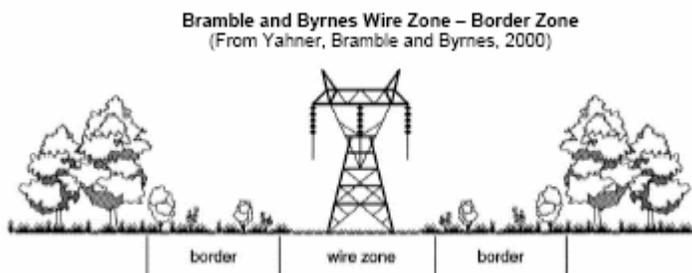
Several transmission owners employ a wire zone – border zone approach which is both environmentally friendly and effective in ensuring reliability. This method involves creating a low-growing vegetation environment directly under transmission lines, which physically prevents dangerous vegetation from encroaching into energized transmission facilities. The CNUC Final Vegetation Report stated that the wire zone-border zone has

“been proven to be effective in reducing and/or eliminating outages related to vegetation on transmission ROW [rights of way].”<sup>30</sup> The wire zone-border zone concept is depicted in the graphic below.

- Application of wire zone – border zone concepts (described below)
- Proper consideration of line sag and sway
- Frequent field inspection of vegetation conditions
- Comprehensive public education programs
